### O'BRIEN & GERE

September 14, 1990

RE: Eagle Lumber Company Property

SUBJ: Site Investigation

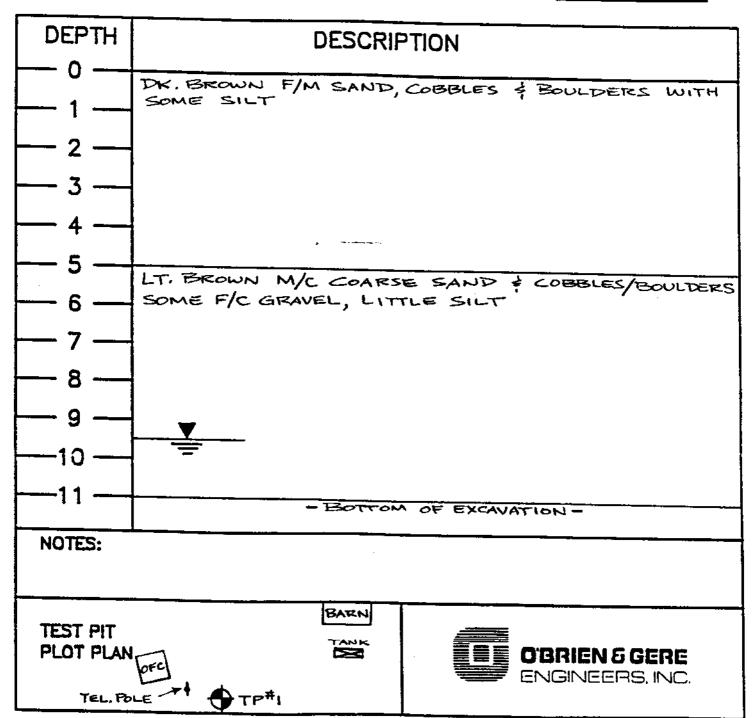
OBG FIELD SUPERVISOR:	PWG	TEST PIT #:T	P-1
WEATHER: OVERCA	ST - 70°		10-90

Soil sample screening produced readings of less than 1 part per million (ppm) of total volatile organic vapors for all samples. Evidence of a petroleum odor or sheen was not apparent in the samples.

Soils in each excavation were observed to be brown sands and gravels with large quantities of cobbles and boulders to depths of approximately 5 to 7 feet. Glacial till was observed below this depth. The till appeared to function as a confining unit for near-surface groundwater on-site because of its compactness and low specific yield. Detailed soil descriptions are provided on Attachment C-Test Pit Logs.
